**BNL-52651
FORMAL REPORT**

**INVESTIGATION IN HARDSURFACING A
NICKEL-COPPER ALLOY
(MONEL 400)**

**Carl Czajkowski and Melissa Butters
Brookhaven National Laboratory
Upton, New York 11973-5000**

December 2001

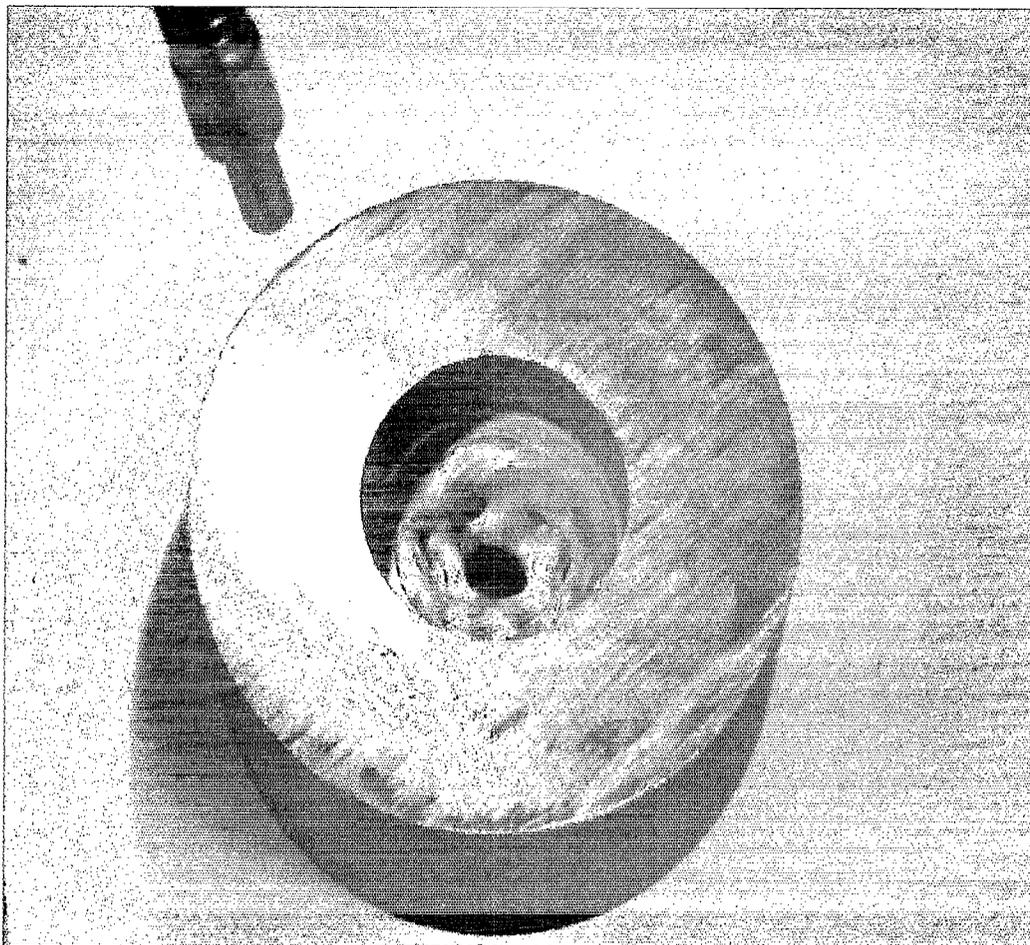
In order to initiate this program, it was mutually agreed (Target Rock/BNL) that BNL would evaluate two heats of Monel 400 material, heats 98-0396 and 99-0950. One of the heats (Inco Alloys Intl. Heat #98-0396) had performed well during manufacturing, producing an acceptable number of "good" parts. The second heat (Allvac heat # 99-0950) from a second manufacturer, had produced some good parts but also exhibited a peculiar type of hardsurfacing/base metal collapse during the welding process. Figure 1 depicts the failure mode evident after welding.

There were linear indications (cracks) evident on the valve body, both on the circumferential area (top of valve body) and below the hard surfaced weld deposit. The heat affected zone (HAZ) also contained linear discontinuities. The valve body was welded using the oxyacetylene welding process, a qualified and skilled welder, and had been given a pre-heat of between 1400-1600⁰F (760-871⁰C), which is the Target Rock qualified procedure requirement.

Discussions with the welder indicated that he had observed a reddish tint (liquid-like in appearance) cover the base metal during the application of the hard surfacing material. He was not specific on gas bubble formation during this operation, which would be indicative of gas trapped in the base metal. Target Rock personnel had indicated that this heat of material had been produced from double vacuum re-melted stock, which should have de-gassed the metal sufficiently to preclude gas entrapment. Ensuing conversations with Target Rock personnel indicated that although this part had failed during hard surfacing, the heat of material (Allvac 99-0950) had produced some acceptable parts for other component configurations. Other than this

Figure 1: Digital Photograph of the Failed Valve Bonnet, After Hard-Surfacing

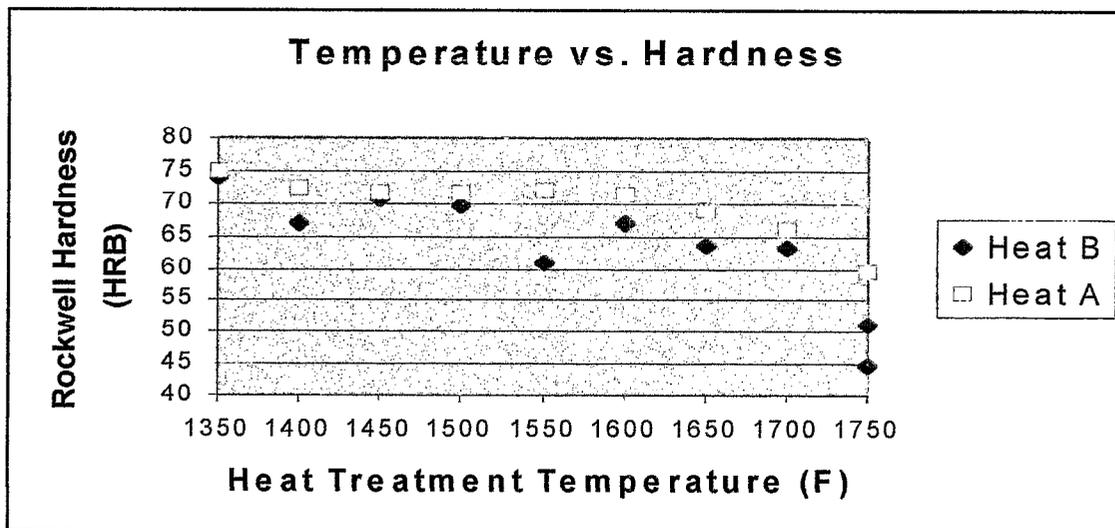
Figure 2: Relationship Between Temperature and Hardness for Heats A (Inco) and B (Allvac)

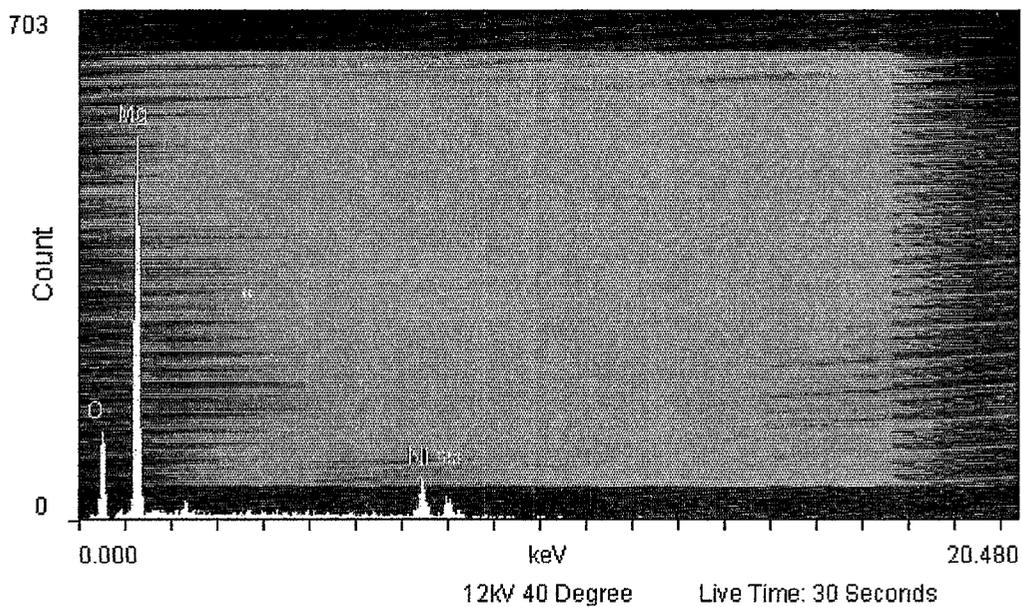
Figure 50a: EDS scan of Pit constituents

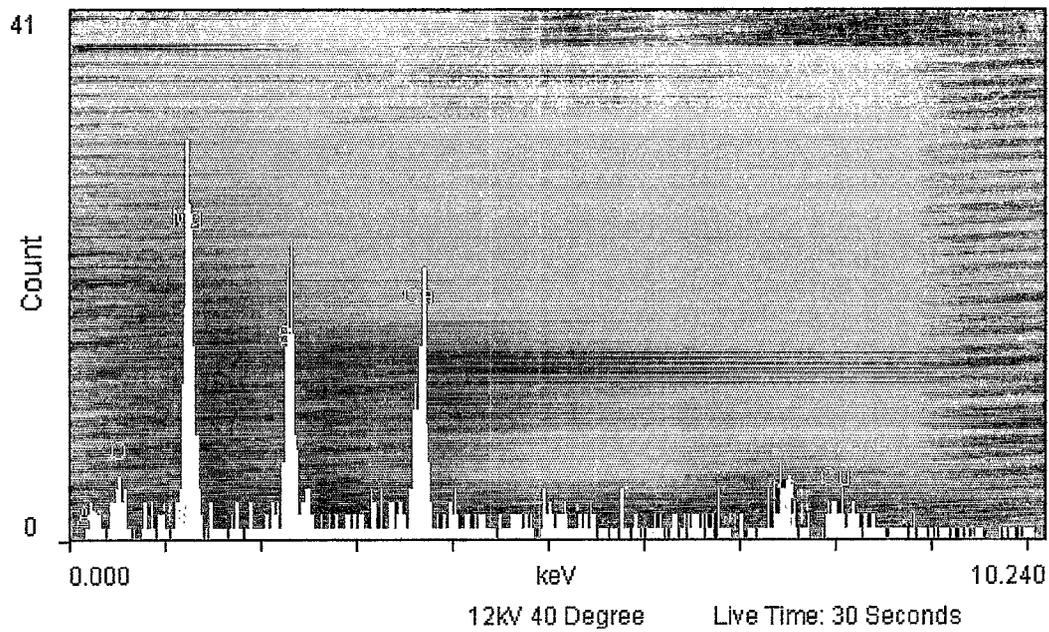
Figure 51a. EDS scan of second pit for chemical constituents

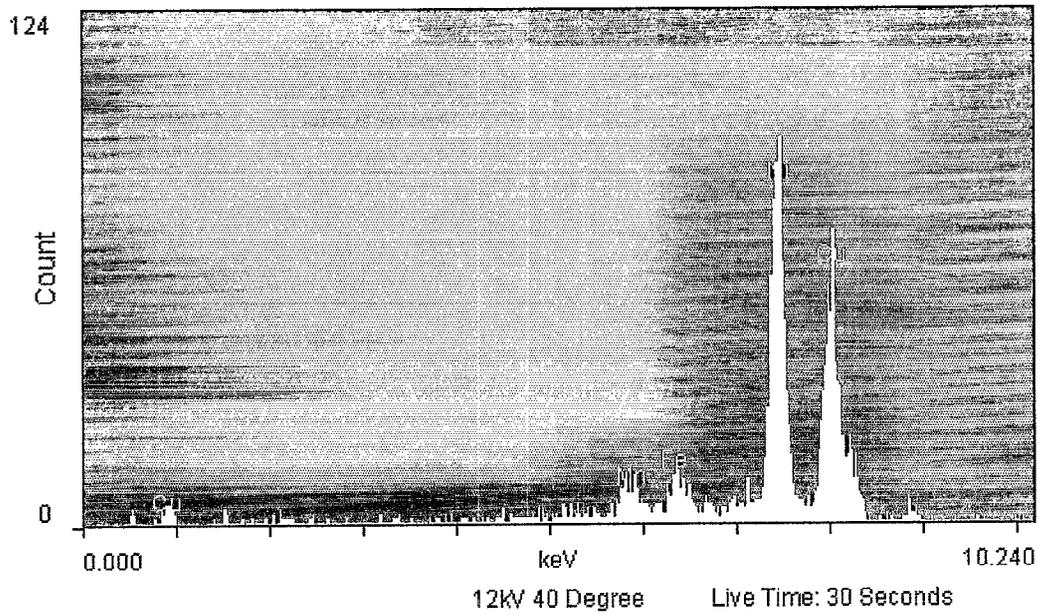
Figure 52a: EDS Scan of Fracture Face, Denoting Chemical Constituents

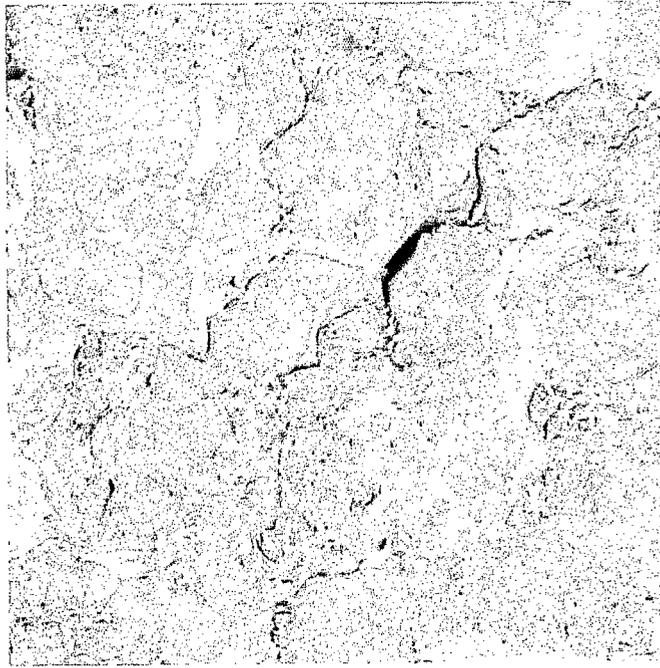
Figure 53: Intergranular Features are Very Distinct in this Fractograph of a Second Area Examined

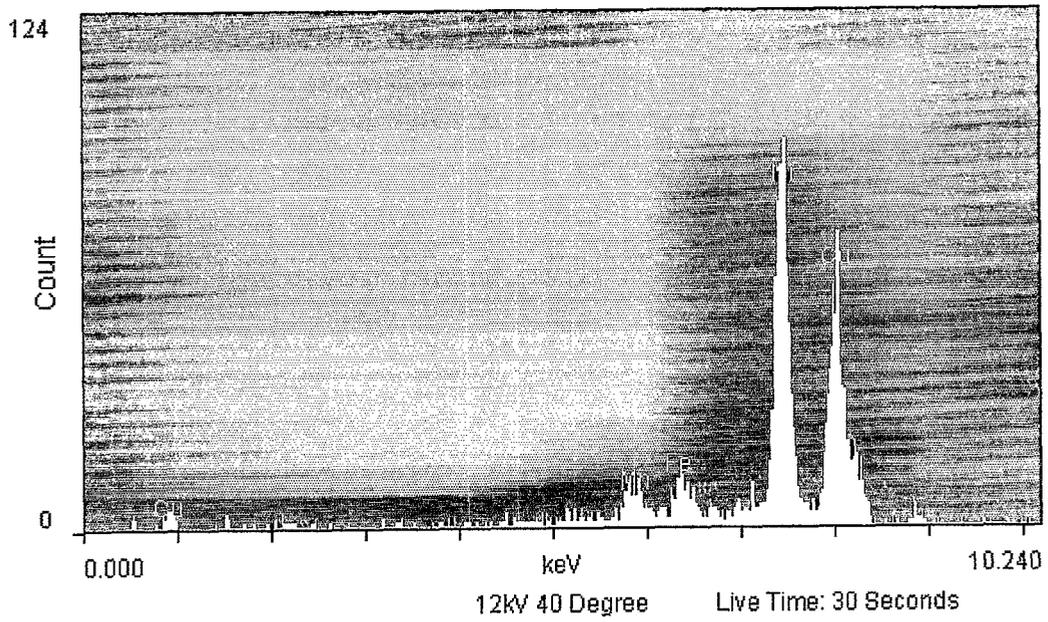
Figure 53a: EDS Scan of Second Area of Crack Examined (Figure 53)

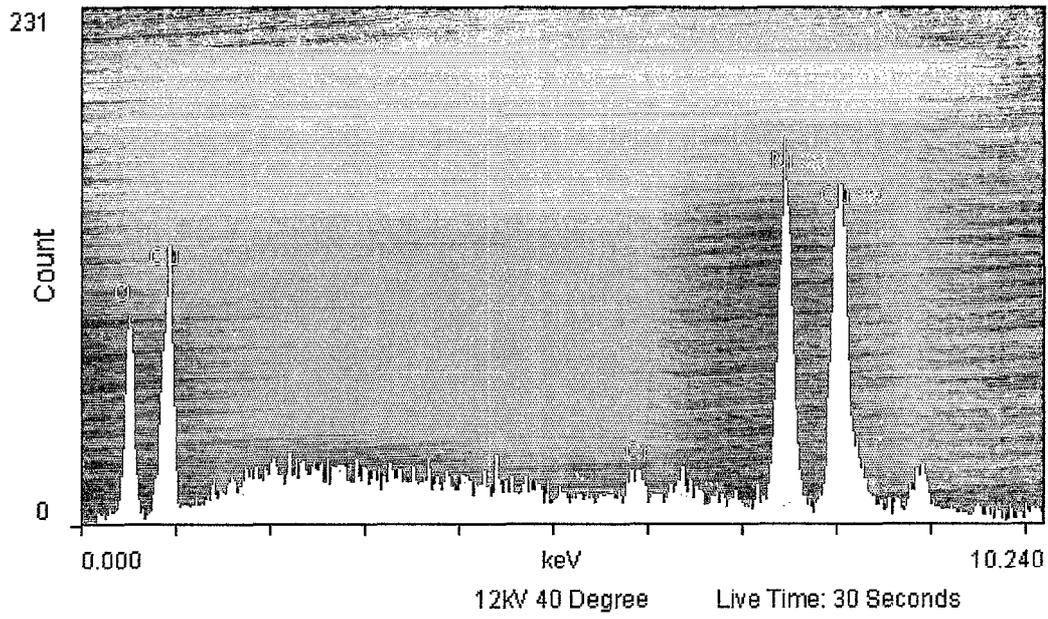
Figure 53b: Third Area of Crack Examined by EDS

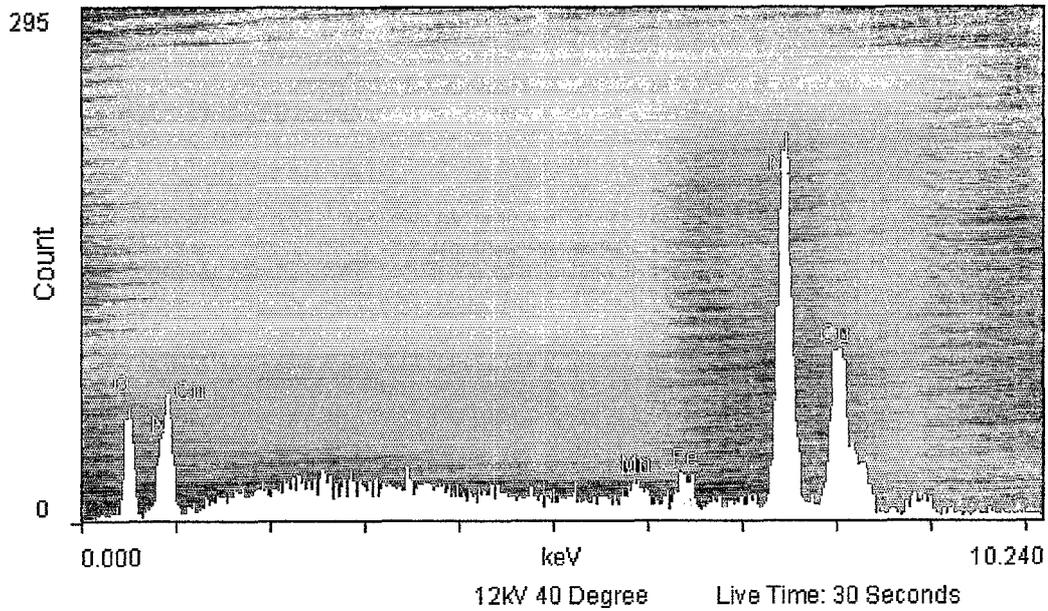
Figure 53c: Fourth Area of Crack Examined by EDS

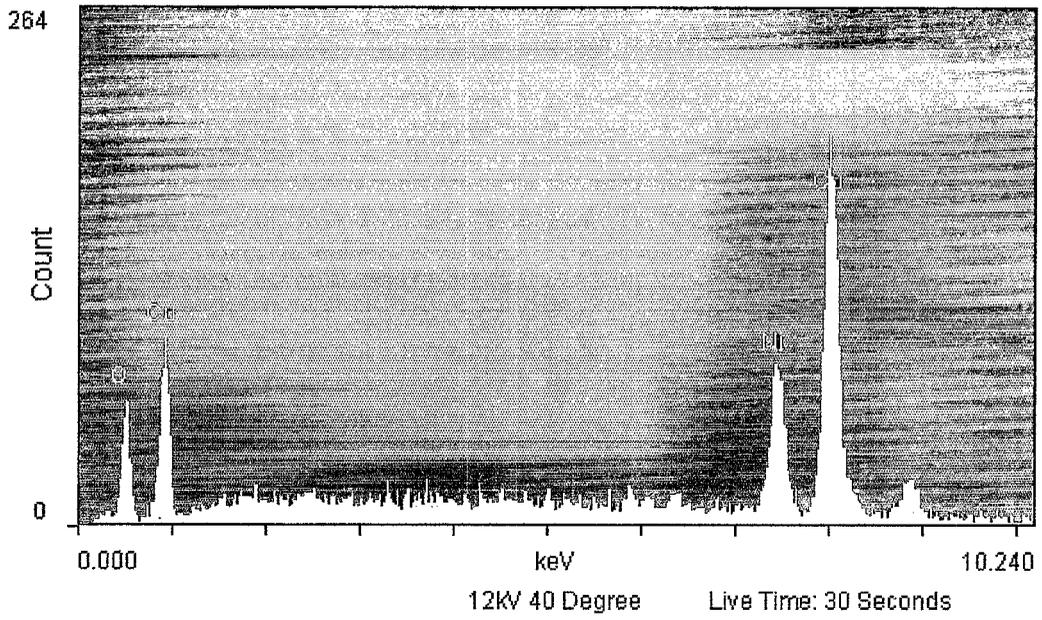
Figure 53d: EDS Spectra of Another Area of the Fracture

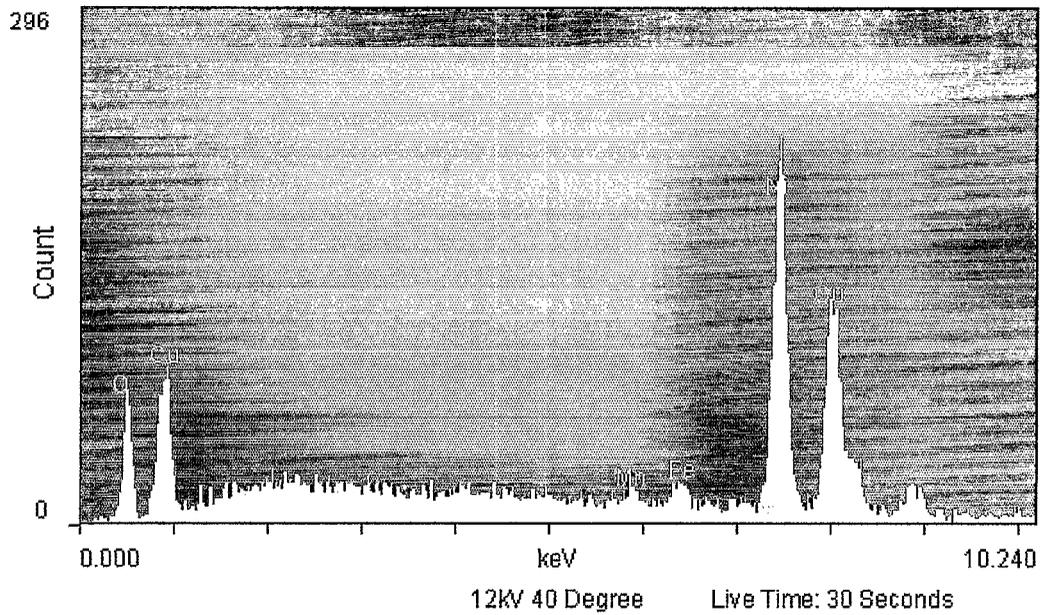
Figure 53e: Last Area of the Fracture Examined by EDS
