**BNL-52651
FORMAL REPORT**

**INVESTIGATION IN HARDSURFACING A
NICKEL-COPPER ALLOY
(MONEL 400)**

**Carl Czajkowski and Melissa Butters
Brookhaven National Laboratory
Upton, New York 11973-5000**

December 2001

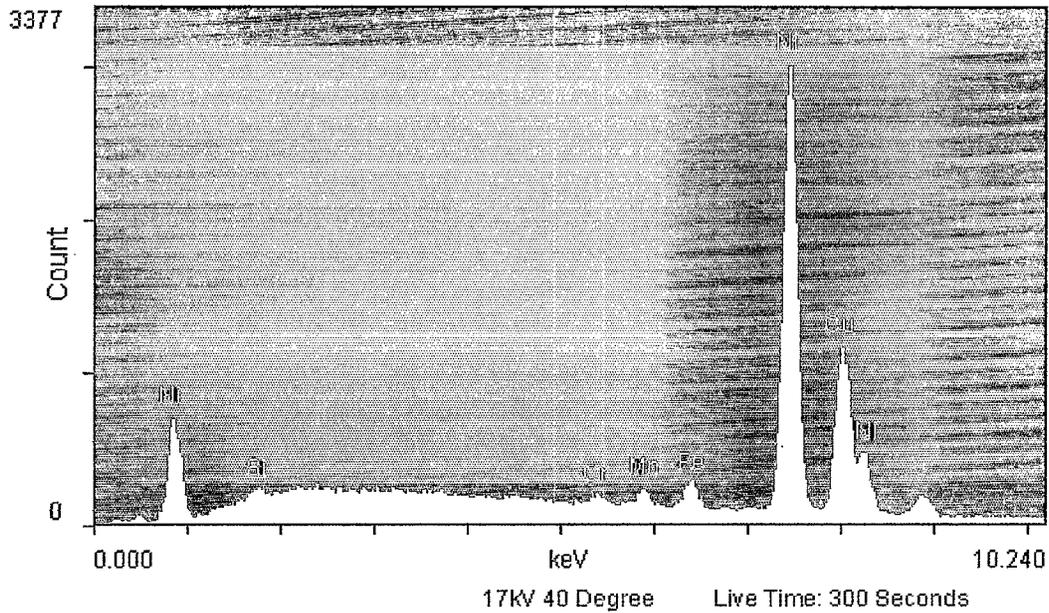
Figure 53e: Last Area of the Fracture Examined by EDS

EDS revealed that the pits visible were composed of combinations of magnesium, calcium, and sulfur (Figures 50, 50a, 51, and 51a). These elements were not included in the original chemical analyses for either heat of material. The fracture surfaces of the crack (Figures 52, 52a, 53, 53b, 53c, 53d, 53e) indicated the crack was intergranular (Figures 52 and 53) and had various oxides present on the fracture surface. As the EDS scan moved deeper into the crack (away from the outside free surface), the values for oxygen (indicating an oxide film) remained quite high (Figures 53a-e). There was no indication that the fracture surfaces had been affected by the weld metal being used since no indications of cobalt were noted in the scans. Figures 54 and 55 are

The presence of low melting point elements on the fracture surfaces introduces the possibility of a grain boundary embrittlement issue. This is only a possibility and is not definite, but should be considered.

In conclusion, the cause of the failure of the valve body during welding is not yet decipherable, however, it does not appear to be a welding issue. The intergranular fractures indicate a grain boundary problem. The lack of cobalt on the fracture face seems to absolve the stellite weld metal from any grain boundary interaction.

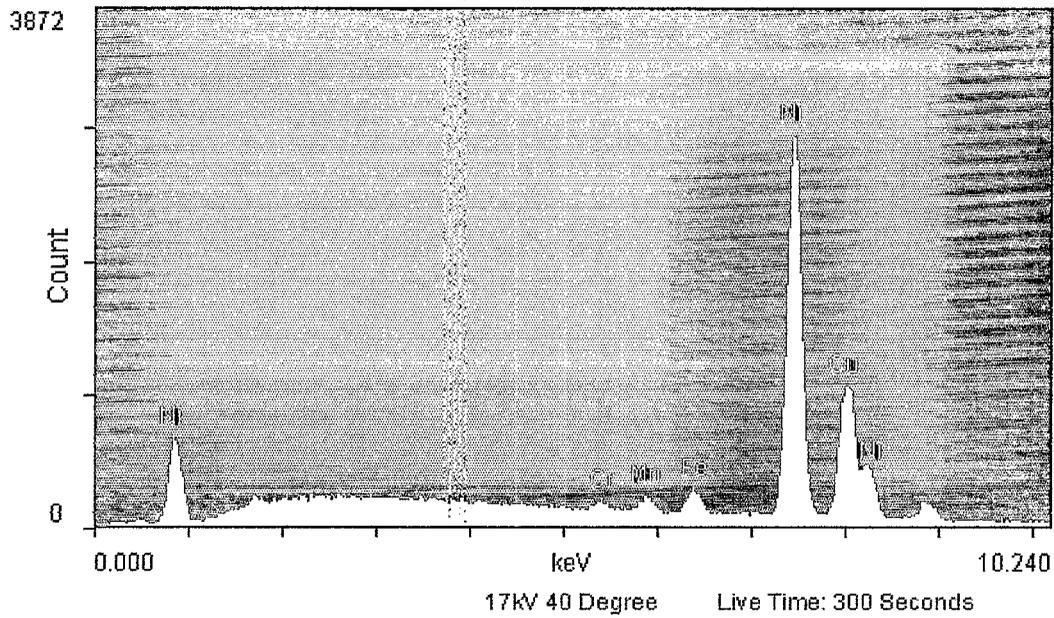
**Figure 54: EDS Quantitative Analysis of Inco Material.
 Quantify Result: Spectrum 3**
